BOA Architecture / Government Services
Rancho Palos Verdes ADA Assessment
Facility Report with Photos

Facility ID: # 02A - City Hall Grounds

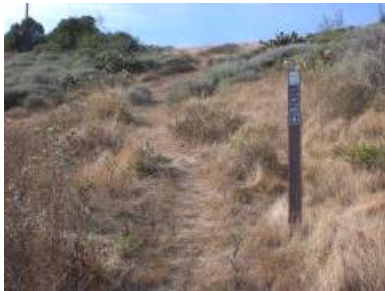
Photo #
1

30.08 - Maintenance of Accessible Trail - Title II Entity - Accessible trail is not in operable working condition. (28 CFR 35.133)

Existing Condition: Landscape on trail.

027 - Site Work - Miscellaneous - See Additional Comments

Additional Comments: See keynote 2 for corrective action.

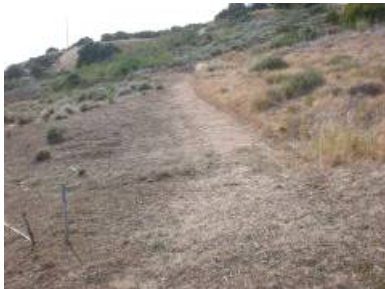
Photo #
2

Existing Condition: 22.5%, 13.5%, 14.2%, & 24.4%

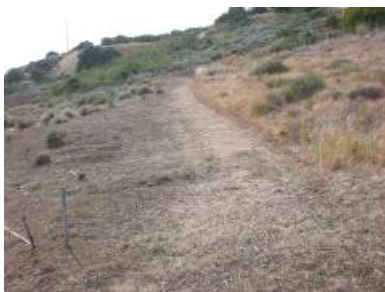
Photo #
2

30.10E - Trail Surface - The surface of the trail is not firm or stable.
Existing Condition: Loose dirt & landscape.

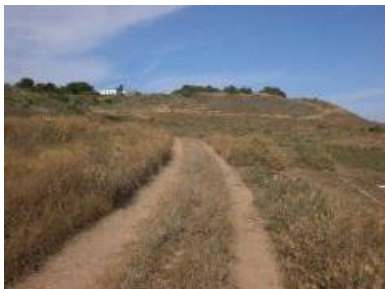
Photo #
4

30.08 - Maintenance of Accessible Trail - Title II Entity - Accessible trail is not in operable working condition. (28 CFR 35.133)
Existing Condition: Landscape on trail.

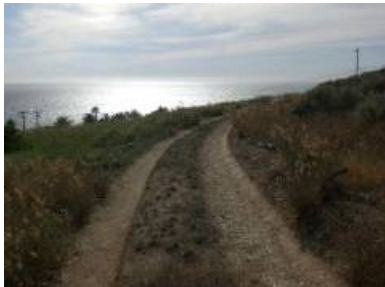
Photo #
4

30.10C - Trail Segment - Cross Slope - Cross slope of the trail segment exceeds 1:20.

Existing Condition: 12.4%, 5.3%, 20.9%, 11.5%, 16.8%...

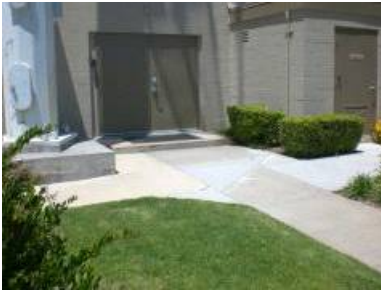
Photo #
16

03B.09 - Cross Slope - Cross slope of the accessible route of travel exceeds 1:50.
Existing Condition: 6.0%, 5.5% & 3.4% at turning point.

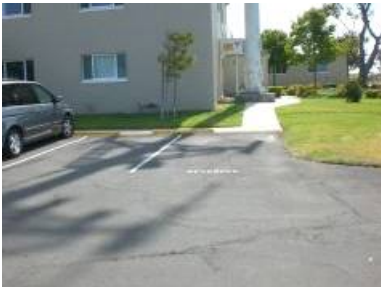
Photo #
17

03B.11 - Ramps - This portion of an accessible route with a slope greater than 5% does not comply with the requirements for compliant ramps.
Existing Condition:

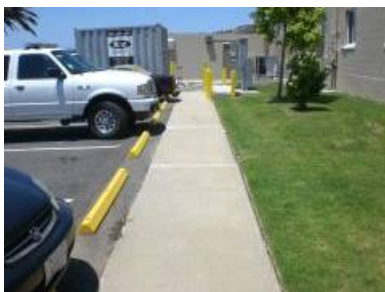
Photo #
18

Existing Condition: 47" wide

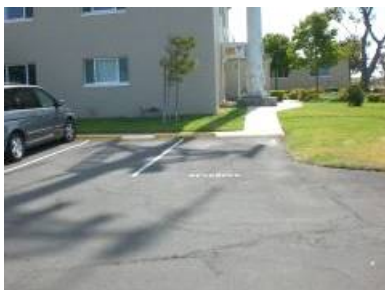
Photo #
17

Existing Condition: 3.2%

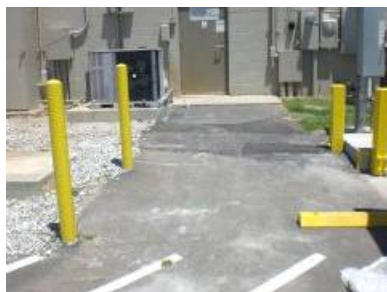
Photo #
22

Existing Condition: 9.5%

Additional Comments: Provide warning sign stating existing condition.

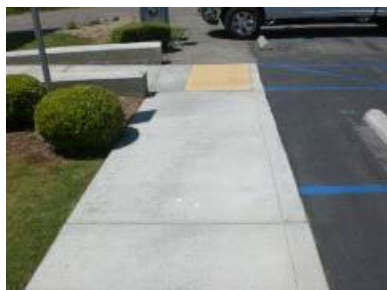
Photo #
28

Existing Condition: 4.6% & 4.4 at mail box

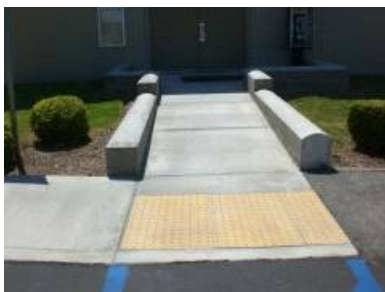
Photo #
36

Existing Condition: 35" wide detectable warnings

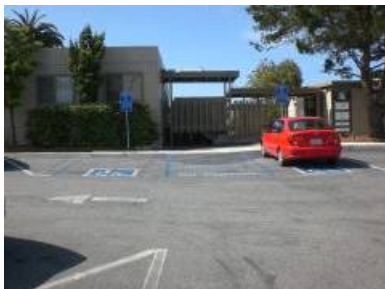
Photo #
37

Existing Condition: 2.6% to 7.2%

194 - Asphalt Paved Parking Stall and Access Aisle - Remove non-compliant pavement and replace with new asphalt paving. The parking space and access aisle slope shall not exceed 2% in any direction.

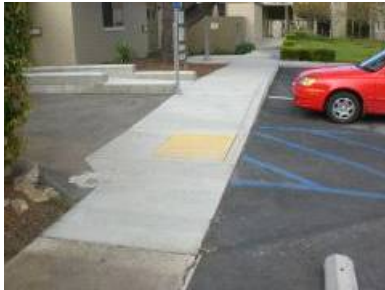
Photo #
42

03B.09 - Cross Slope - Cross slope of the accessible route of travel exceeds 1:50.
Existing Condition: 3.3%

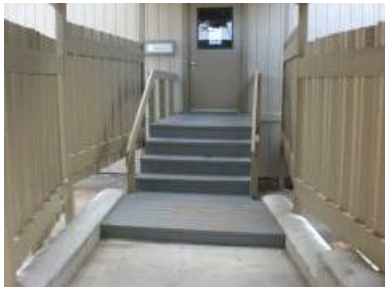
Photo #
43

03B.13 - > 1/2" Changes in Level - Curb ramps, ramps, or elevators are not used for changes in level greater than 1/2 inch. (Lifts may only be used in certain limited situations.)
Existing Condition: 5 1/4" to 8" Steps.

257A - Replace Stairs - Replace stairs to comply with rise/run requirements.
Additional Comments: Relocate container & provide accessible POT from exit door to front entrance door by means of deck with guardrails.

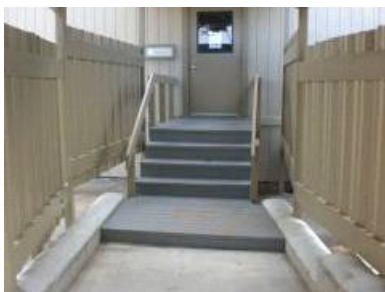
Photo #
43

Existing Condition: 8" high.

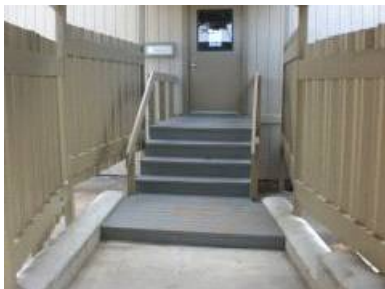
Photo #
43

Existing Condition: 3.5%

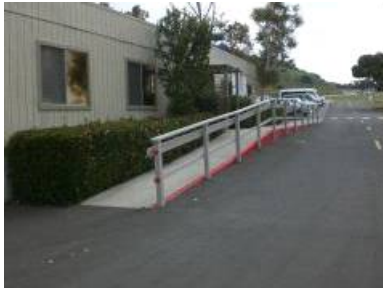
03B.21 - Hazardous Vehicular Areas - Detectable Warnings - Where a walk crosses or adjoins the vehicular way and the walking surface is not separated by curbs, railings, or other elements between the pedestrian areas and vehicular areas, the boundary between the areas is not defined by a continuous detectable warning at least 36" wide complying with CBC 1121B.3.1 item 8(a). (i.e., the warning surface shall contrast visually with adjoining surfaces, either light on dark or dark on light, and shall differ from adjoining walking surfaces in resiliency or sound on cane contact. Color: yellow conforming to Federal Color No. 33538, Table IV/ Standard No. 595B. Where the color value contrast between the yellow warning and the main walking surface is less than 70 percent, a 1" wide black strip shall separate the yellow warning from the main walking surface.)

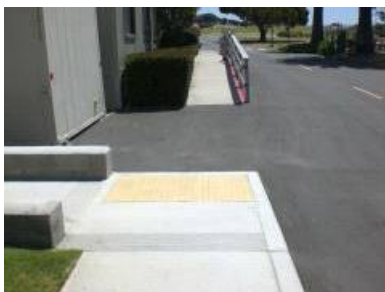
Keynote 72

Existing Condition: 3.1%

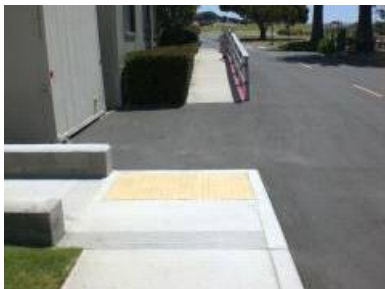
Keynote 73

Existing Condition: 5.8%

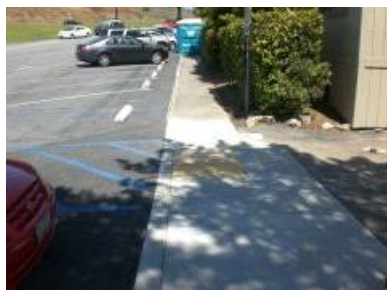
Keynote 75

Existing Condition: 2.8 CS

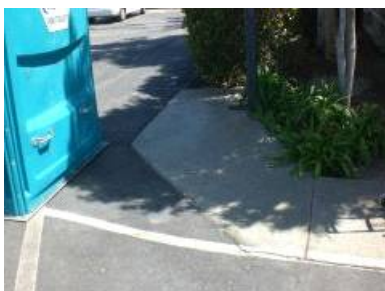
Keynote 77

Existing Condition: 8.2%

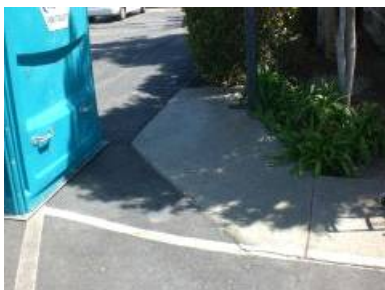
Keynote 78

Existing Condition: 10.8%

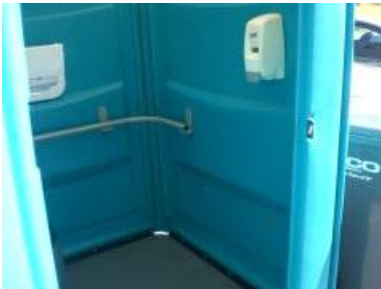
Keynote 93

Existing Condition: 46" high

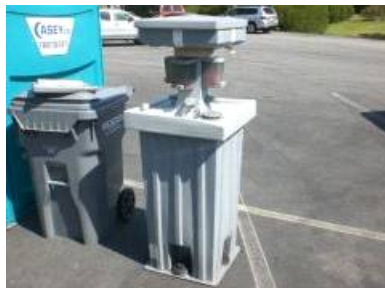
Keynote 98

Existing Condition: 45" high

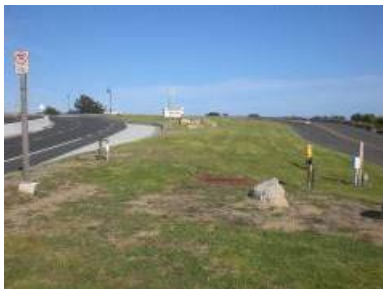
Keynote 107

03B.01 - On-site Accessible Route of Travel - There is no accessible route within the property line of the site linking an accessible building entrance with site arrival points serving the following, if provided: public transportation stops, accessible parking, passenger loading zones, and public sidewalks.

Existing Condition: 20.9% CS & 6.2% RS at grass area.

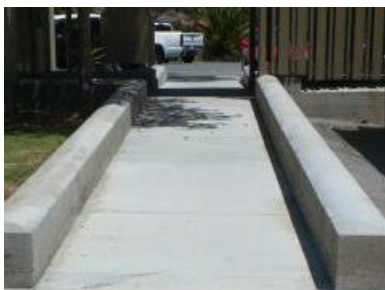
Keynote 108

Existing Condition: 3.0%

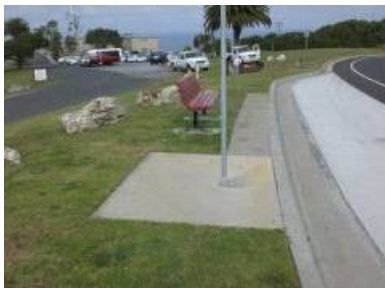
Keynote 109

Existing Condition: 2'-0" x 24'-9"

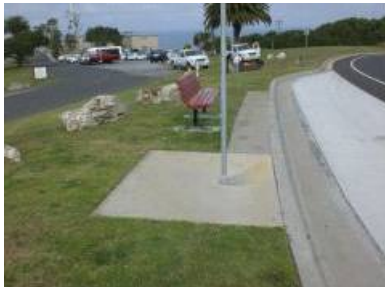
Keynote 111

Existing Condition: 4.5% sidewalk & 5.1% road.

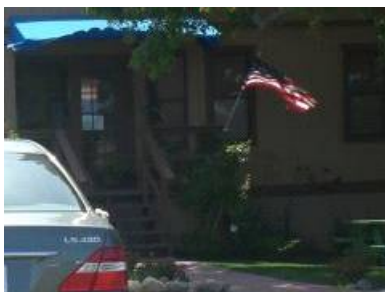
Keynote 116

08.09A - Handrail Extensions - Top Landing - At ends of handrails, less than 12" of handrail extends beyond the top nosing. (Top and bottom handrail extensions are important safety features for persons with balance problems and must extend in the direction of the stair run to permit the intended use.) (Per ADA/CBC Standards, in existing buildings and facilities, full extension of handrails at stairs shall not be required in alterations where such extensions would be hazardous or impossible due to plan configuration.)

Existing Condition: None

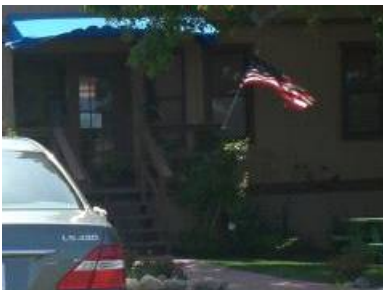
Keynote 118

Existing Condition: 2 1/8"

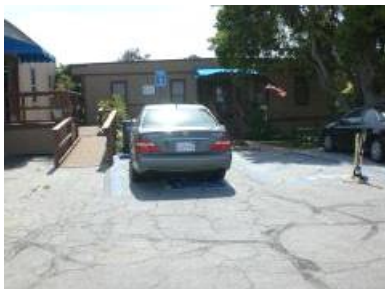
Keynote 120

Existing Condition: 7'-8" wide.

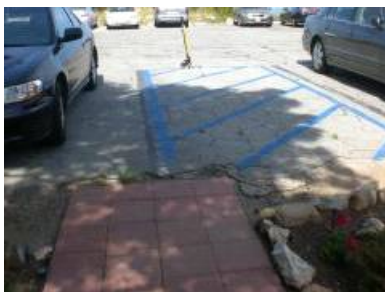
Keynote 121

Existing Condition: 2.7% & 3.3%

194 - Asphalt Paved Parking Stall and Access Aisle - Remove non-compliant pavement and replace with new asphalt paving. The parking space and access aisle slope shall not exceed 2% in any direction.

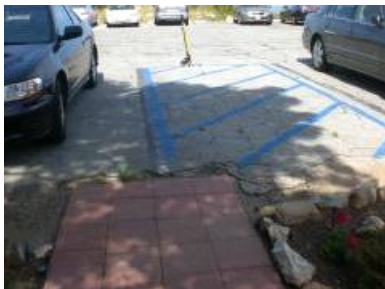
Keynote 122

Existing Condition: Cracks & deterioration.

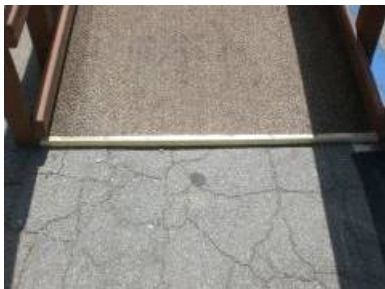
Keynote 126

Existing Condition: 1 1/2" high.

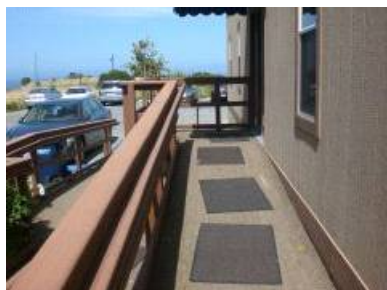
Keynote 128

Existing Condition: 8 floor mats

Additional Comments: Remove floor loose floor mats.

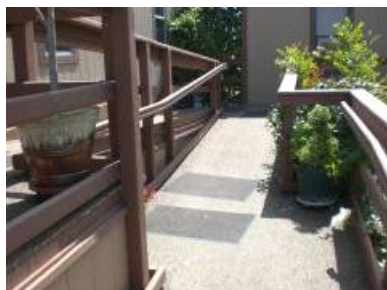
Keynote 130

Existing Condition: 74" x 70"

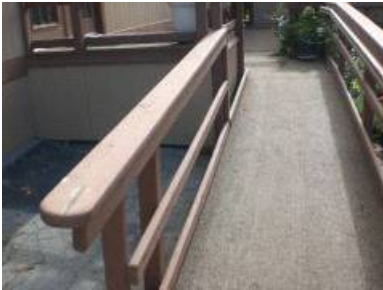
Keynote 133

Existing Condition: 33" high

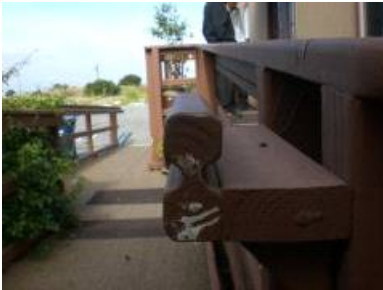
Keynote 135

07.24 - Clearance - The clear space between handrails and walls is not 1-1/2" absolute. (ADA/CBC Standards apply an absolute dimension of 1-1/2", which provides knuckle clearance while generally disallowing entrapment of the forearm or elbow.)

Existing Condition: 2 1/8"

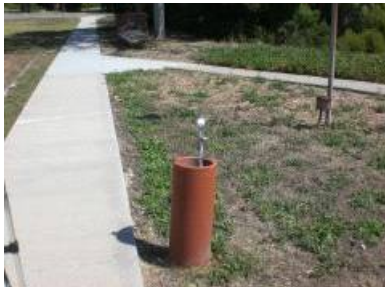
Keynote 142

03B.09 - Cross Slope - Cross slope of the accessible route of travel exceeds 1:50.

Existing Condition: 3.1% at landing.

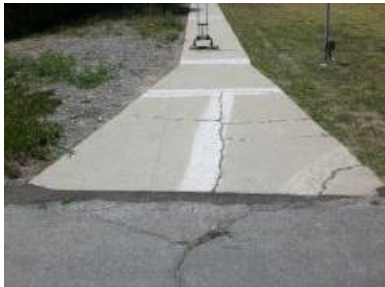
Keynote 144

Location: Walkway from Comm. Dev. Bldg. to Ch 33 Bldg.
Photo # 141

03B.15 - Surface - Accessible route surfaces are not stable, firm and slip-resistant.
 Existing Condition: Cracks

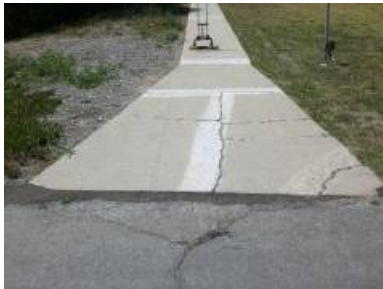
Keynote 145

03B.21 - Hazardous Vehicular Areas - Detectable Warnings - Where a walk crosses or adjoins the vehicular way and the walking surface is not separated by curbs, railings, or other elements between the pedestrian areas and vehicular areas, the boundary between the areas is not defined by a continuous detectable warning at least 36" wide complying with CBC 1121B.3.1 item 8(a). (i.e., the warning surface shall contrast visually with adjoining surfaces, either light on dark or dark on light, and shall differ from adjoining walking surfaces in resiliency or sound on cane contact. Color: yellow conforming to Federal Color No. 33538, Table IV/ Standard No. 595B. Where the color value contrast between the yellow warning and the main walking surface is less than 70 percent, a 1" wide black strip shall separate the yellow warning from the main walking surface.)

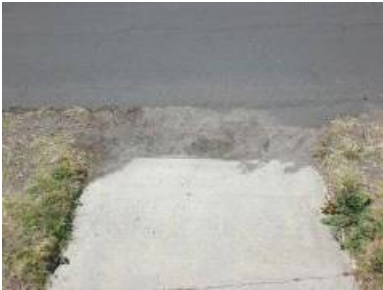
Keynote 146

03B.15 - Surface - Accessible route surfaces are not stable, firm and slip-resistant.

Existing Condition: Cracks & loose surface

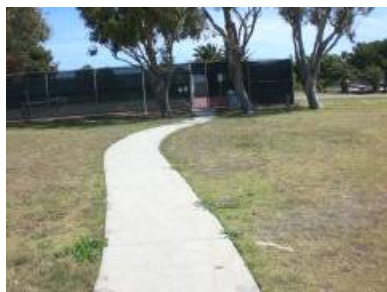
Keynote 148

Location:
Tennis Walkway

03B.09 - Cross Slope - Cross slope of the accessible route of travel exceeds 1:50.
 Existing Condition: 3.3%, 3.9%, & 4.7%

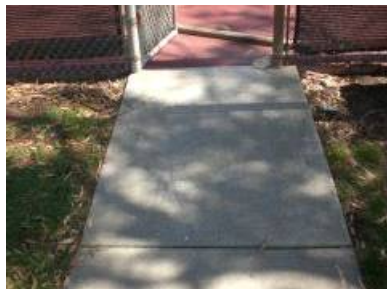
Keynote 149

Location:
Tennis Entrance

03B.12 - > 1/4" Changes in Level - Where walkway levels change abruptly, the vertical difference between them exceeds 1/4 inch. Or changes in level between 1/4 inch and 1/2 inch are beveled with a slope greater than 1:2.
 Existing Condition: 1/4" high

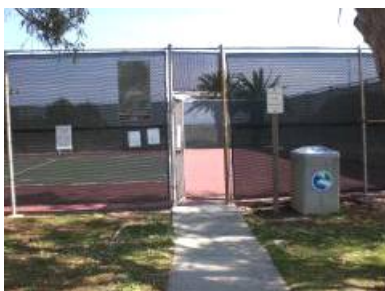
Keynote 150

Location:
Tennis Entrance

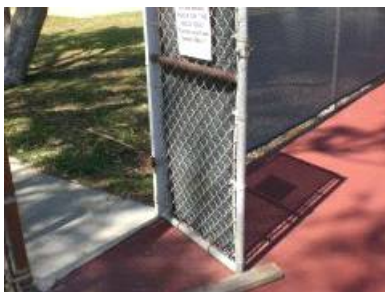
Keynote 152

Location:
Tennis Entrance

10.08 - Kick Plate - Bottom 10" of door does not have a smooth, uninterrupted surface on the push side to allow the door to be opened by a wheelchair footrest without creating a trap or hazardous condition. (This requirement does not apply to automatic and sliding doors.)

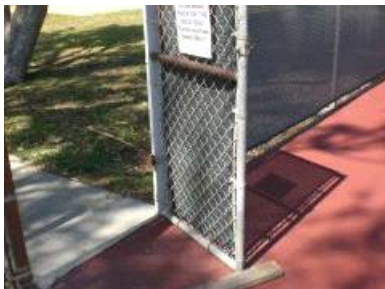
Keynote 153

Location:
Tennis Entrance

Existing Condition: Door scrapes.

058 - Realign Door Mounting - Realign existing door so door does not scrape against the jamb. Remove and replace existing door hinges.

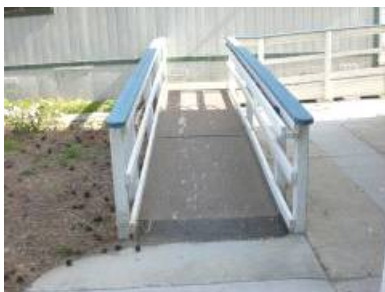
Keynote 154

Location:
Ramp at Ch 33 Bldg.

Existing Condition: 45" clr.

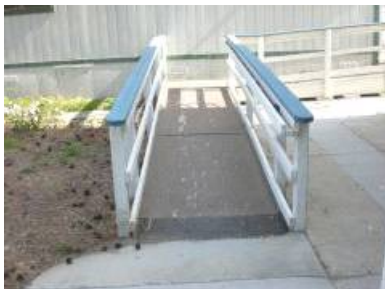
Keynote 155

Location:
Ramp at Ch 33 Bldg.

Existing Condition: 4.3%

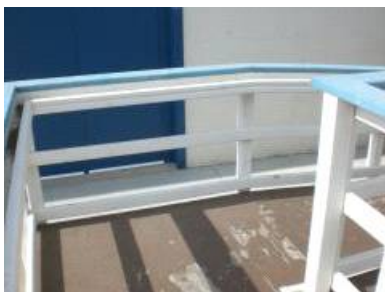
Keynote 156

Location:
Ramp at Ch 33 Bldg.

Existing Condition: 73" long 45" wide.

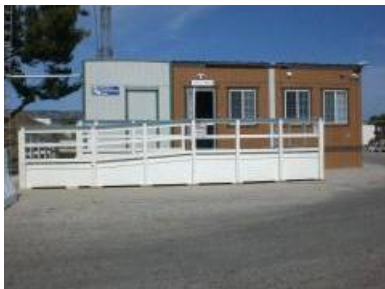
Keynote 157

Location:
Ramp at Ch 33 Bldg.

Existing Condition: 32 3/4" high guards.

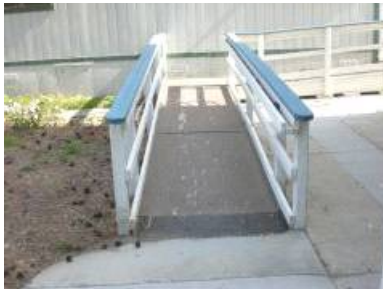
Keynote 158

Location:
Ramp at Ch 33 Bldg.

07.21A - Extensions - Required Length - At ends of handrails, less than 12" of handrail extends beyond the top and bottom of the ramp segment. (Top and bottom handrail extensions are important safety features for persons with mobility impairments and must extend in the direction of the ramp run to permit the intended use.) (Per CBC 1133B.5.5.1.1, in existing buildings or facilities, where the extension of the handrail in the direction of the ramp run would create a hazard, the extension on the handrail may be turned 90 degrees to the run of the ramp.)

Existing Condition: One provided.

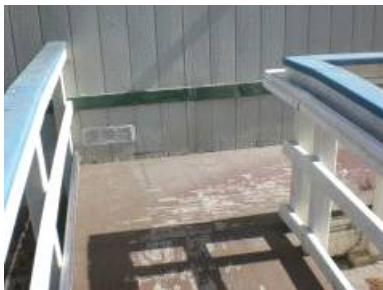
Keynote 159

Location:
Ramp at Ch 33 Bldg.

Existing Condition: 2 1/8" clr.

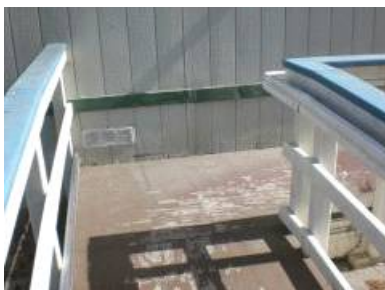
Keynote 160

Location:
Ramp at Ch 33 Bldg.

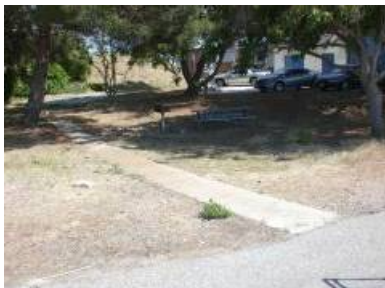
Keynote 161

Location:
N. of Ch 33 Bldg. Picnic Area

Existing Condition: 30" wide walkway

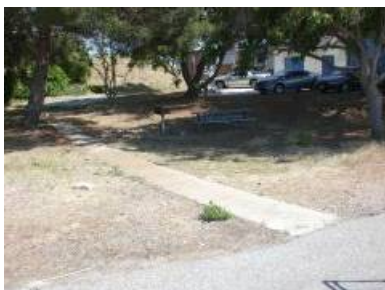
Keynote 162

Location:
N. of Ch 33 Bldg. Picnic Area

03B.10 - Running Slope - Slope of the accessible route of travel exceeds 1:20.
Existing Condition: 7.6%

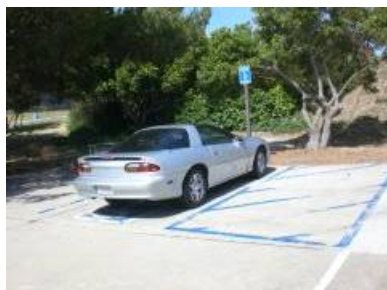
Keynote 166

Location:
Parking at Ch 33 Bldg.

Existing Condition: 7'-7" wide

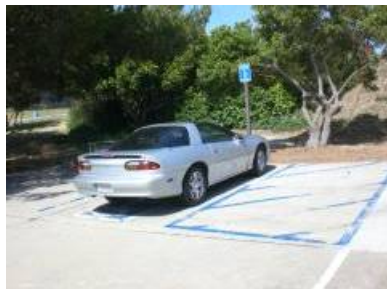
Keynote 167

Location:
Parking at Ch 33 Bldg.

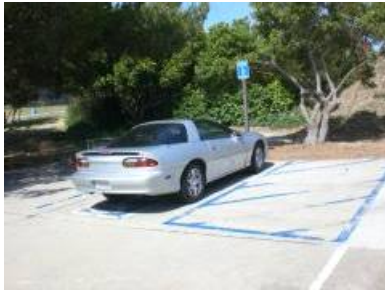
Keynote 168

Location:
Parking at Ch 33 Bldg.

Existing Condition: 48" x 48"

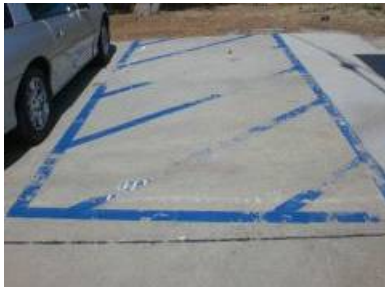
Keynote 169

Location:
Parking at Ch 33 Bldg.

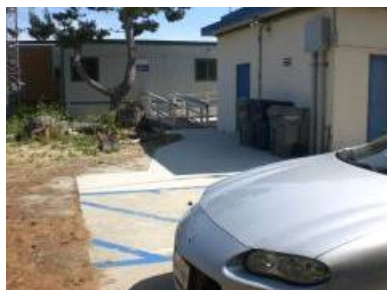
Keynote 171

Location:
N. Walkway at Ch 33 Bldg.

Existing Condition: 6.1%

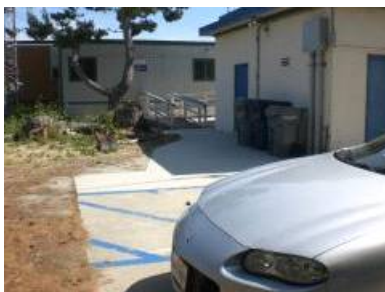
Keynote 172

Location: N. Walkway at Ch 33 Bldg.
Photo # 172

03B.09 - Cross Slope - Cross slope of the accessible route of travel exceeds 1:50.
 Existing Condition: 2.7% & 11.4 from accessible bldg. entrances.
